REPAIR INFO FOR Clutch Hydraulics

Part Numbers: 875035

For Vehicle: Chevrolet, Opel, and Vauxhall Models

CSC 875035 BEST FITTING PRACTICES

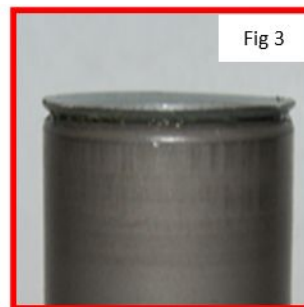
The piston retaining ring has deformation or rippling. This shows that the cylinder has been overstroked.

This issue is caused by a top hat seal located on the inlet/actuator pipe remaining in the female connector when the old unit is removed. This creates a one way valve situation allowing fluid into the internal CSC chamber but not allowing it to return. Too much fluid in the CSC will cause the bearing to over travel and force it past its end position and beyond the CSC retaining ring.

If the clutch pedal becomes hard, DO NOT depress the pedal further!

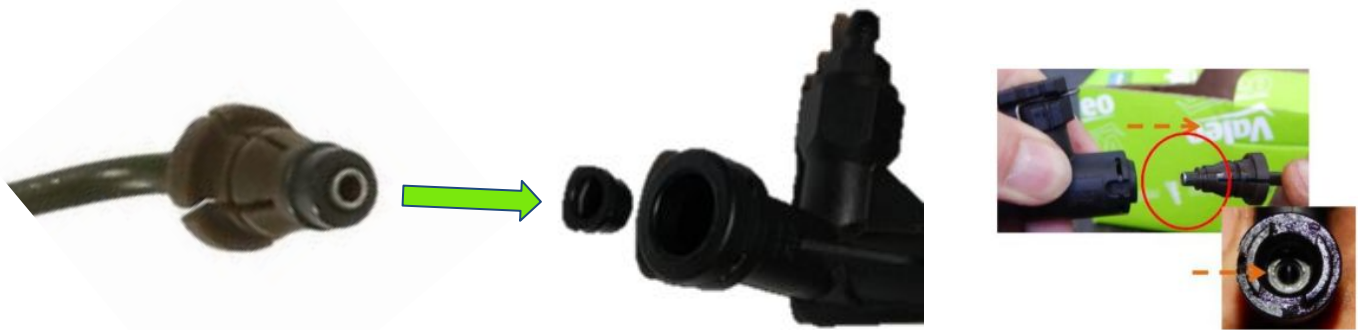
Subsequent depressions of the clutch pedal will fill the CSC until its full travel and a stiff pedal will occur. If this stiff pedal is overcome the CSC will over stroke and burst, necessitating a replacement.

The condition of the seal should also be checked to ensure it has not split, is worn or is swollen before fitting a new CSC.
