REPAIR INFO FOR Clutch Hydraulics

Part Numbers: 810226

For Vehicle: Abarth, Alfa, Chevrolet, Fiat, Opel, Saab, and Vauxhall Models

CSC 810226 BEST FITTING PRACTICES

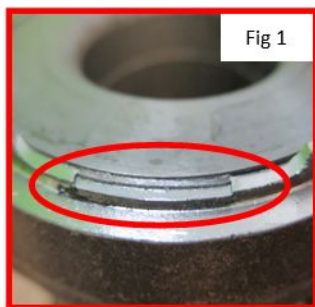
Before fitting the unit, ensure the gearbox mating face is clean and clear from debris. If it is not this can cause the unit to sit unevenly on the gearbox (Fig 2) giving the potential for the back plate to be forced out by the hydraulic pressure (Fig 1).

Unit returned has the back plate forced out; this is caused by the back plate not being supported by the gearbox mating face.

When fitting the unit to the gearbox, be sure to tighten the bolts evenly and to the correct torque in order to guarantee that the unit sits square on the gearbox mating face. This will ensure the back plate is fully supported.

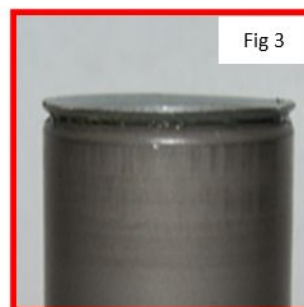
Check the hydraulic line for any defects or blockages. If the clutch pedal goes hard or does not return to its resting position after each depression during the bleeding process, do not continue to try and bleed the hydraulic system. Continuing to do so will result in too much fluid entering the fluid chamber within the CSC and will cause the piston retaining ring to move past its stopping point. In Fig 3 you can see deformation/rippling. This shows that the cylinder has been over stroked.

The piston retaining ring has deformation or rippling. This shows that the cylinder has been overstroked.

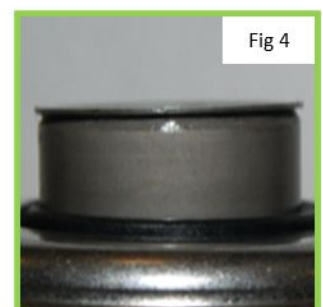
The piston retaining ring has no deformation or rippling. This shows that the cylinder has not been overstroked.

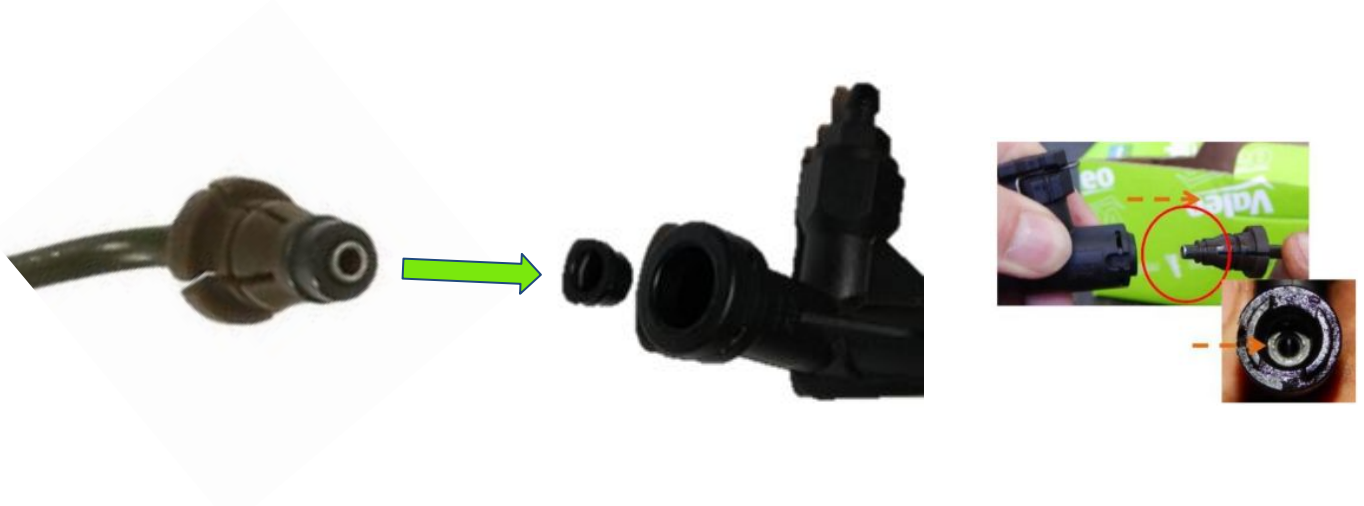
This issue is caused by a top hat seal located on the inlet/actuator pipe remaining in the female connector when the old unit is removed. This creates a one way valve situation allowing fluid into the internal CSC chamber but not allowing it to return. To much fluid in the CSC will cause the bearing to over travel and force it past its end position and beyond the CSC retaining ring.

Subsequent depressions of the clutch pedal will fill the CSC until its full travel and a stiff pedal will occur. If this stiff pedal is overcome the CSC will over stroke and burst, necessitating a replacement.

If the clutch pedal becomes hard, DO NOT depress the pedal further!

The condition of the seal should also be checked to ensure it has not split, is worn or is swollen before fitting a new CSC.
