REPAIR INFO FOR Clutch Hydraulics

Part Numbers: 875035

For Vehicle: Chevrolet, Opel, and Vauxhall Models

CSC 875035 BEST FITTING PRACTICES

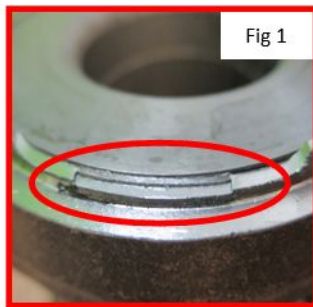
Unit returned has the back plate forced out; this is caused by the back plate not being supported by the gearbox mating face.

When fitting the unit to the gearbox, be sure to tighten the bolts evenly and to the correct torque in order to guarantee that the unit sits square on the gearbox mating face. This will ensure the back plate is fully supported.

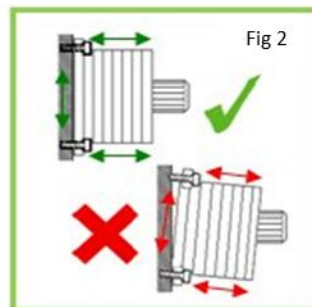
Before fitting the unit, ensure the gearbox mating face is clean and clear from debris. If it is not this can cause the unit to sit unevenly on the gearbox (Fig 2) giving the potential for the back plate to be forced out by the hydraulic pressure (Fig 1).

Ensure the gearbox mating face is clear from debris and the unit is sitting flush before tightening the bolts.

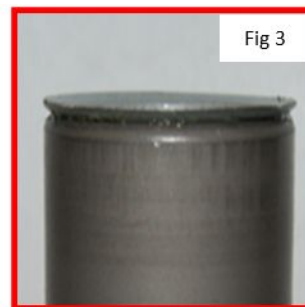
The piston retaining ring has deformation or rippling. This shows that the cylinder has been overstroked.

If the clutch pedal becomes hard, DO NOT depress the pedal further!

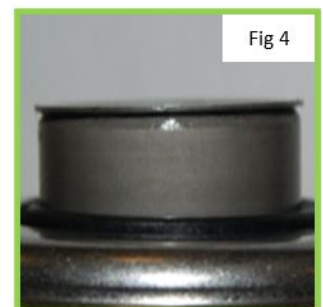
The piston retaining ring has no deformation or rippling. This shows that the cylinder has not been overstroked.

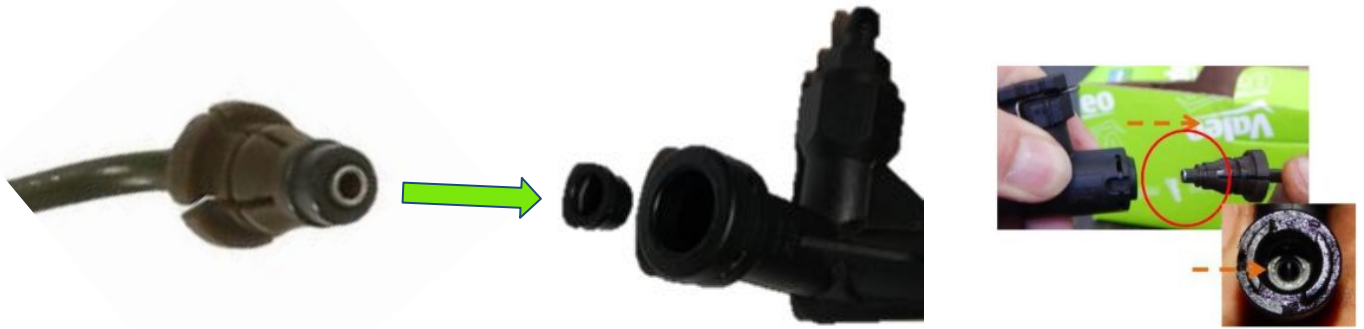
This issue is caused by a top hat seal located on the inlet/actuator pipe remaining in the female connector when the old unit is removed. This creates a one way valve situation allowing fluid into the internal CSC chamber but not allowing it to return. Too much fluid in the CSC will cause the bearing to over travel and force it past its end position and beyond the CSC retaining ring.

Subsequent depressions of the clutch pedal will fill the CSC until its full travel and a stiff pedal will occur. If this stiff pedal is overcome the CSC will over stroke and burst, necessitating a replacement.

The condition of the seal should also be checked to ensure it has not split, is worn or is swollen before fitting a new CSC.
