REPAIR INFO FOR Clutch Hydraulics

Part Numbers: 810226

For Vehicle: Abarth, Alfa, Chevrolet, Fiat, Opel, Saab, and Vauxhall Models

CSC 810226 BEST FITTING PRACTICES

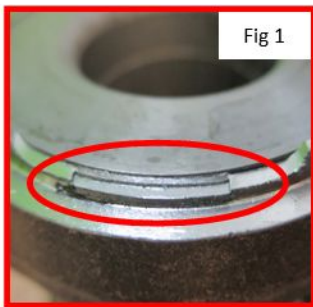
Unit returned has the back plate forced out; this is caused by the back plate not being supported by the gearbox mating face.

When fitting the unit to the gearbox, be sure to tighten the bolts evenly and to the correct torque in order to guarantee that the unit sits square on the gearbox mating face. This will ensure the back plate is fully supported.

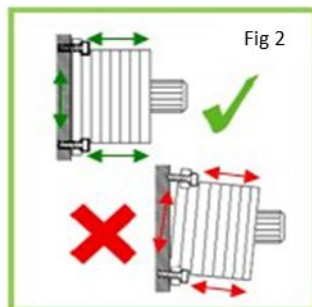
Before fitting the unit, ensure the gearbox mating face is clean and clear from debris. If it is not this can cause the unit to sit unevenly on the gearbox (Fig 2) giving the potential for the back plate to be forced out by the hydraulic pressure (Fig 1).

Ensure the gearbox mating face is clear from debris and the unit is sitting flush before tightening the bolts.

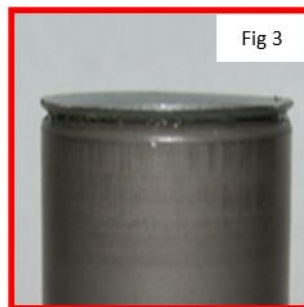
The piston retaining ring has deformation or rippling. This shows that the cylinder has been overstroked.

After further investigation the clutch pedal was becoming hard after the second or third depression of the pedal and the CSC leaks when the pedal is depressed further.

If the clutch pedal becomes hard, DO NOT depress the pedal further!

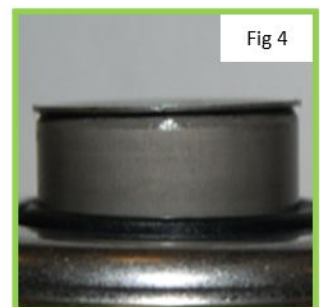
The piston retaining ring has no deformation or rippling. This shows that the cylinder has not been overstroked.

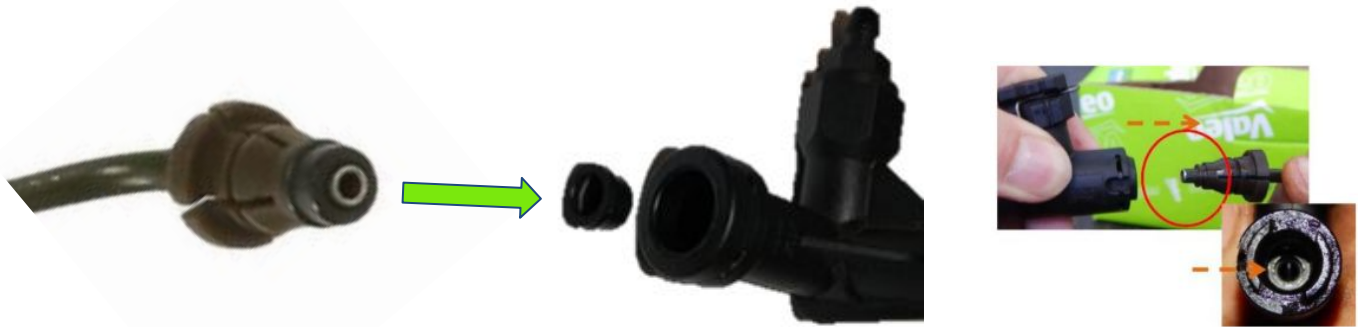
This issue is caused by a top hat seal located on the inlet/actuator pipe remaining in the female connector when the old unit is removed. This creates a one way valve situation allowing fluid into the internal CSC chamber but not allowing it to return. To much fluid in the CSC will cause the bearing to over travel and force it past its end position and beyond the CSC retaining ring.

Subsequent depressions of the clutch pedal will fill the CSC until its full travel and a stiff pedal will occur. If this stiff pedal is overcome the CSC will over stroke and burst, necessitating a replacement.

The condition of the seal should also be checked to ensure it has not split, is worn or is swollen before fitting a new CSC.
