Technical Bulletin

July 2020 TSB-VSA-IGN-072020-01

Ignition coil

245141

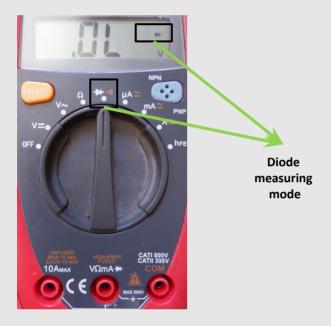
Fig. 1

As you see in the electrical pinout, if the engine ground potential is not conform with the electric body potential you are on risk to damage the internal ECU or the driver controller.

- Measure the internal resistance of the primary coil by using the multimeter, connect positive & negative probe of multimeter on pin 3 & pin 2 respectively, standard value should be 0.5 to 0.9 ohms (as shown in Fig.1)

- Measure the secondary coil resistance by adjusting the the multimeter on diode resistance mode (Fig. 4) and connect the positive & negative probe of multimeter on HV (High-Voltage) & PIN 2 respectively (as shown in Fig. 1), the measured value should be more than 6000 ohms.

- Measure the **protective** resistance 390 ohms by connecting the multimeter probes on PIN 1 & PIN 4 (Fig. 1)
