NEWS

Water pump failure causes

Causes of water pump failure

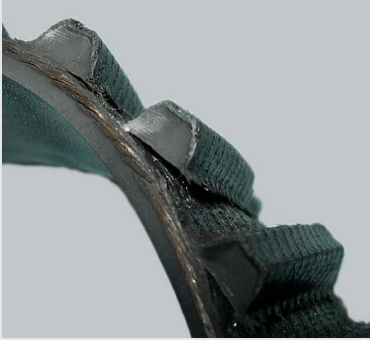
Cause III: Belt wear

Cause	<ul style="list-style-type: none"> • Low belt tension • Penetration of foreign matter
Affected area	Cut and wear in belt contact area
Picture

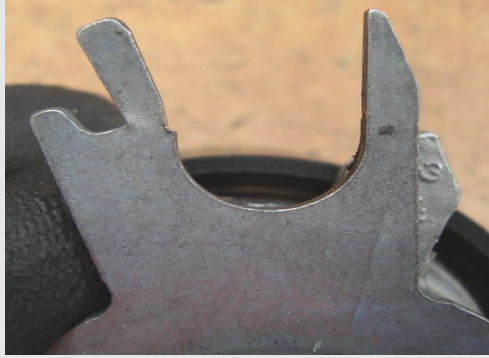
Cause IV: Damaged tensioner

Cause	Wrong fitting
Affected area	Damaged in belt tensioner
Picture

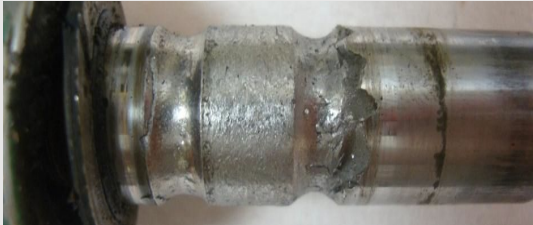
Cause V: Pitting on bearing shaft

Cause	<ul style="list-style-type: none"> • Excessive tension on bearing • Sudden overload due to external causes • Bad assembly/performance of some belt idler
Affected area	On bearing shaft
Picture
