Damaged clutch cover during fitment

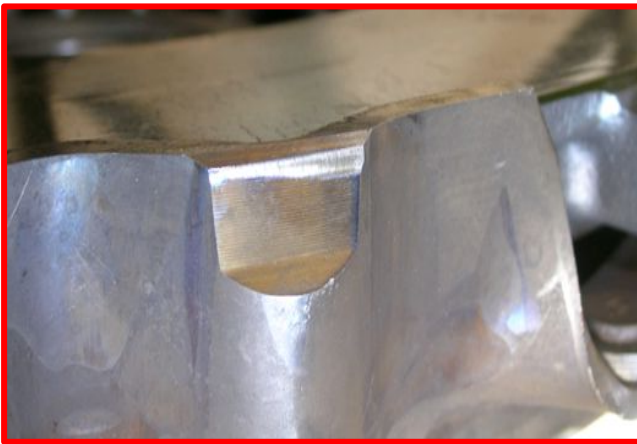
The Valeo Warranty team have received several clutch claims where, upon inspection, it has been found that the clutch cover has been damaged. Deformation of the outer edge can be seen either as a result of the clutch cover not being seated correctly on the flywheel during fitment, or the clutch cover has impacted the flywheel shoulder during placement.

Valeo Service recommend using guidance installation pins when fixing CV clutch covers on their respective flywheels. This ensures that the clutch cover is in its accurate position. If the clutch cover is damaged, it should not be refitted.
