## Wheel Hub Damage Analysis Guide

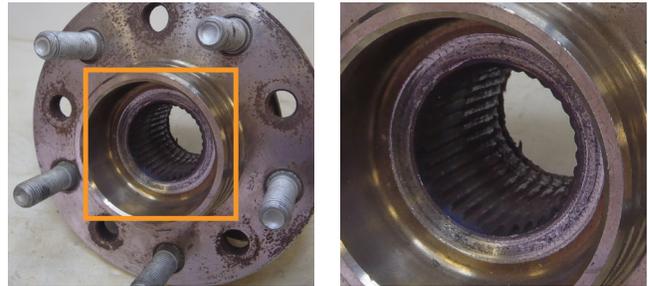
**Symptoms:** Wheel vibration and/or excessive noise.

**Diagnosis:** Rough or worn axle retaining nuts indicate movement due to loss of bearing retention. Refer to the original equipment manufacturer's instructions or visit [timkeninfo.com](http://timkeninfo.com) to identify the proper torque for the axle retaining nut.

**Cause:** Loss of bearing retention is the leading cause of hub bearing damage, resulting in wheel vibration and/or noise.

The axle-retaining nut backs off when bearings demonstrate improper torque or have lost their self-retention features. This changes the setting of the bearings inside the hub, causing misalignment and accelerating wear.

Tighten axle lock nut to proper torque to help avoid rough and worn surface under the nut.

**Solution:** Always use a new axle retaining nut and tighten it to the proper torque to avoid a rough and worn surface under the nut.

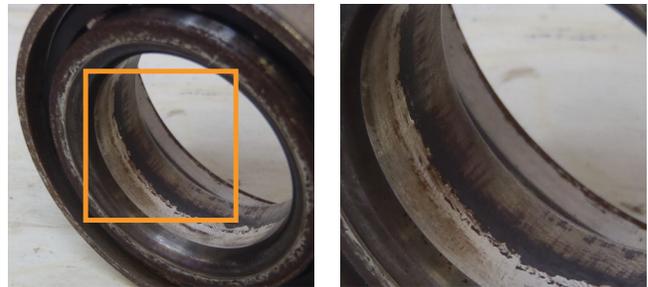
**Symptoms:** Accelerated bearing wear or multiple returns for the same wheel end application.

**Diagnosis:** Inspect the hub barrel when replacing a wheel bearing with a separate hub. Check the hub barrel outer diameter (OD) for signs of damage. Look for ridges or discoloration on the barrel surface due to heat damage from cone turning. Replace the hub if you find any signs of damage.

**Cause:** Loss of axle retention or reinstalling a worn hub can allow the cone or inner race to spin on the hub, accelerating wear on the cone bore and hub barrel. This cone turning can indicate loss of bearing retention or improper fit between the cone bore and hub barrel diameter.

Reduce excessive wear by using hubs in good condition.

**Solution:** If you see damage to the hub barrel, replace it.

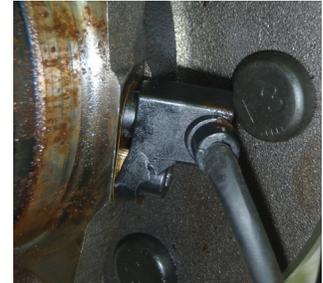
**Symptoms:** A damaged sensor cable or a broken wheel speed sensor turned the anti-lock braking system (ABS) light on.

**Diagnosis:** Look for damage from sharp objects or evidence that the cable was caught in a pinch point. Ensure the cable is routed through the entire sensor cable retaining clip. If the sensor cable is not damaged, examine the external sensor for cracks in the sensor body or a loose cable in the sensor head.

Avoid pinched cable by using retainer clips.

**Cause:** Sharp objects may have damaged, pinched or bent the sensor cable. Sensor cable damage is a common cause of ABS malfunctions. Installation may have damaged the wheel speed sensor.

**Solution:** Route sensor cable through all retaining clips. Use hubs in good condition to reduce wear. Avoid pinched cable by using retainer clips.
