TIPS & TRICKS

Hoses diagnostics

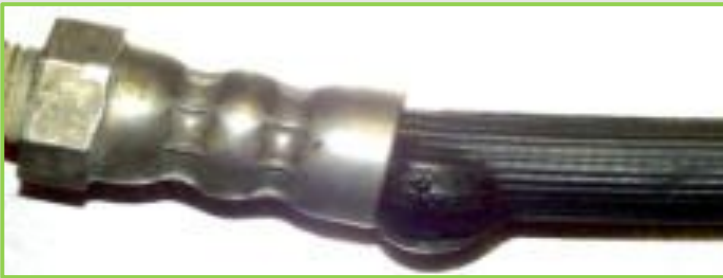
Bubbles

The presence of bubbles in the reinforcement of hydraulic brake hoses can occur due to a phenomenon known as "cavitation."

Cavitation happens when the pressure within the hydraulic system drops below the vapor pressure of the fluid. As a result, tiny vapor bubbles form within the fluid, including within the reinforcement layers of the brake hoses.

This cavitation can be caused by several factors, such as sudden pressure changes, high fluid velocities, or restrictions in the hydraulic system. When these bubbles collapse or explode, they create shock waves that can lead to damage within the reinforcement layers of the brake hoses.

It is important to address and prevent bubble formation in the reinforcement of hydraulic brake hoses as it can compromise the structural integrity of the hoses, reduce braking efficiency, and potentially lead to brake failure. Regular inspection, maintenance, and ensuring proper hydraulic system design are crucial in mitigating the risk of bubble formation and maintaining the safety and performance of the braking system.

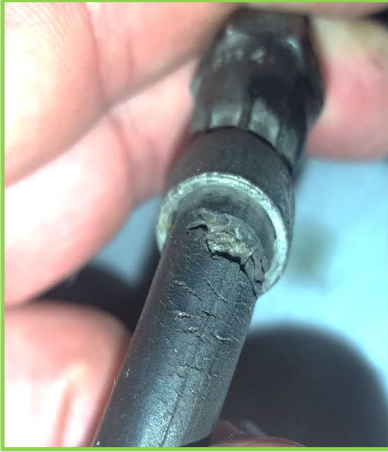
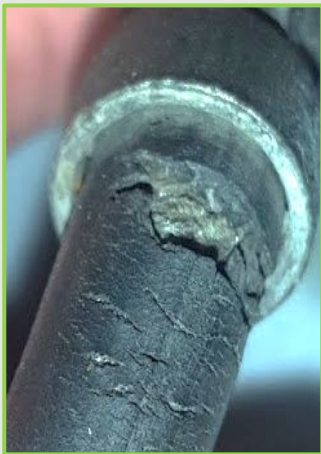
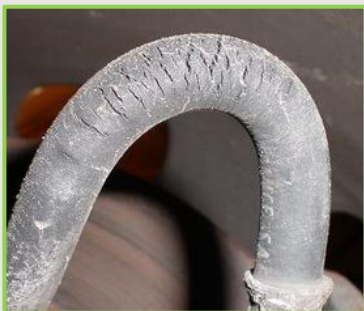
Crack formation

Some common causes of crack formation in hydraulic brake hoses include:

1. Age and wear: Over time, hydraulic brake hoses can experience degradation and wear due to exposure to heat, chemicals, and mechanical stress. This can lead to the development of cracks in the hose material.

2. Flexing and bending: Hydraulic brake hoses are subjected to repeated flexing and bending during normal vehicle operation. This continuous movement can cause fatigue in the hose material, eventually leading to crack formation.

3. Improper installation: Incorrect installation techniques, such as improper tightening or routing of the hoses, can create stress points that contribute to crack formation over time.

4. External damage: External factors such as impact, abrasion, or contact with sharp objects can cause physical damage to the brake hoses, resulting in cracks.

5. Environmental factors: Exposure to extreme temperatures, chemicals, or harsh environmental conditions can weaken the hose material and make it more prone to cracking.

To prevent crack formation in hydraulic brake hoses, regular inspection and maintenance are essential. It is crucial to monitor the condition of the hoses, looking for signs of cracking, fraying, or bulging.

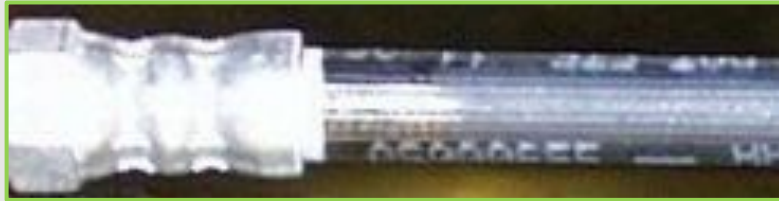
Leakage

A leak in the reinforcement can compromise the integrity and performance of the braking system. Here are some possible causes and actions to take:

1. Physical damage: The reinforcement of the brake hose may have experienced physical damage, such as cuts, punctures, or abrasions, which have caused a leak. In this case, the damaged hose should be replaced promptly to ensure the safety of the braking system.

2. Corrosion: Corrosion can weaken the reinforcement of the brake hose, leading to leaks. This is particularly common in areas where the brake system is exposed to moisture or corrosive substances. If corrosion is identified, the affected hose should be replaced, and measures should be taken to prevent further corrosion.

3. Incorrect installation: Improper installation techniques, such as over-tightening or using incompatible fittings, can cause damage to the reinforcement and result in leaks. Reinstallation of the brake hose following the correct procedures and using appropriate fittings may be necessary.

When a leak in the reinforcement of a hydraulic brake hose is detected, it is crucial to address the issue promptly to prevent brake fluid loss, loss of braking power, or potential brake failure.

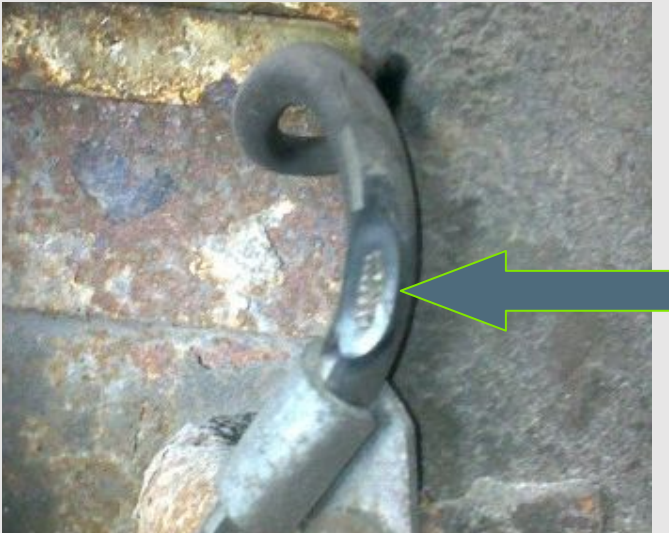
Abrasion can weaken the hose material and potentially lead to leaks or other forms of damage. Here's some important information regarding external abrasion and how to address it:

External abrasion can be caused by various factors, such as contact with sharp edges, rubbing against other components or surfaces, or improper routing of the brake hose. It is important to identify the source of abrasion to effectively mitigate the issue.

Regular visual inspection of the brake hoses is crucial to detect any signs of abrasion. Look for areas where the outer surface of the hose appears worn, frayed, or damaged. Pay close attention to sections where the hose comes into contact with other components, such as suspension parts, body panels, or metal edges.

Ensure that the brake hoses are correctly routed and secured to minimize contact with potential abrasive surfaces. Use appropriate clips, brackets, or protective sleeves to provide additional protection and prevent direct contact between the hose and any abrasive objects.

If significant abrasion is observed on the outer surface of the brake hose, it is recommended to replace the affected hose. Abrasion compromises the structural integrity of the hose and increases the risk of leaks or failure.
